JB Home Inspections, Inc.

RE: 1234 Main Street
Anytown, USA

REPORT SUMMARY

January 1, 2010

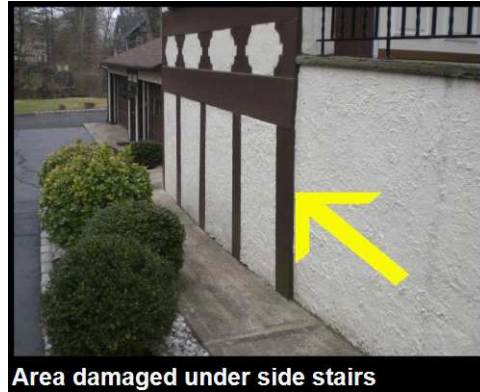
1. The stucco wall under the side door entrance area is in need of repair. There is loose stucco, rot and deterioration. The wall has started to lean out. There was no access behind this area or under the stairs to determine the full extent of the damage, further evaluation and repair is needed.
2. Termite mud tunneling was noted on the sill plate above the gas meter, recommend having the home treated for termites and maintaining the service contract with the treatment company.
3. Mold and water stains were noted on the ceiling material in the attic. Structural fire damage was noted on the roof rafters. We were not able to determine the extent of the fire damage due to the ceiling material restricting our view. Recommend removal of all ceiling material and a complete inspection and evaluation of the roof structure by a qualified contractor.

Area damaged under side stairs

The stucco wall under the side door entrance area is in need of repair. There is loose stucco, rot and deterioration. The wall has started to lean out. There was no access behind this area or under the stairs to determine the full extent of the damage, further evaluation and repair is needed.

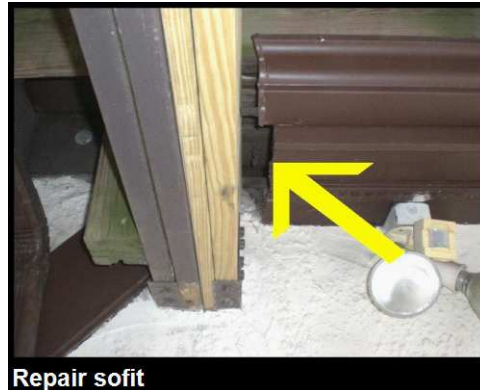
Repair soffit

There is a section of the soffit that is missing on the rear of the garage at the main beam for the deck. Repairs are recommended.

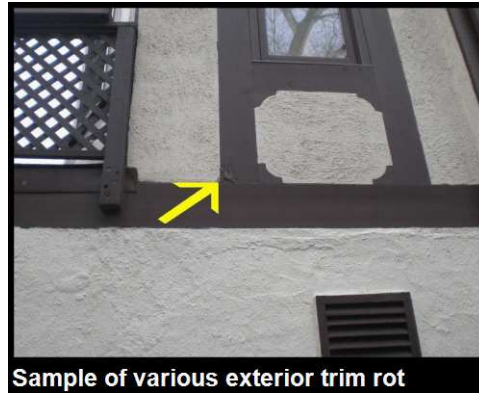
Rot was noted under the side kitchen window, on the rear kitchen windows and some various areas around the exterior.

Sample of various exterior trim rot

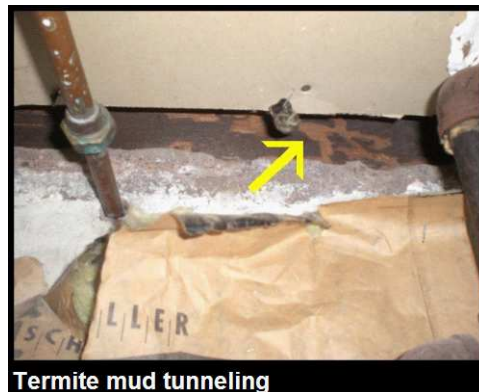
Termite mud tunneling

Termite mud tunneling was noted on the sill plate above the gas meter, recommend having the home treated for termites and maintaining the service contract with the treatment company.

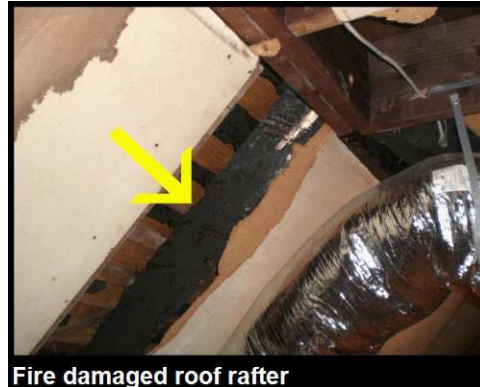
Fire damaged roof rafter

Mold and water stains were noted on the ceiling material in the attic. Structural fire damage was noted on the roof rafters. We were not able to determine the extent of the fire damage due to the ceiling material restricting our view. Recommend removal of all ceiling material and a complete inspection and evaluation of the roof structure by a qualified contractor.

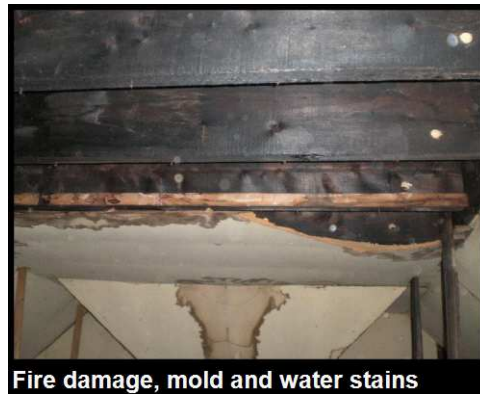
Fire damage, mold and water stains

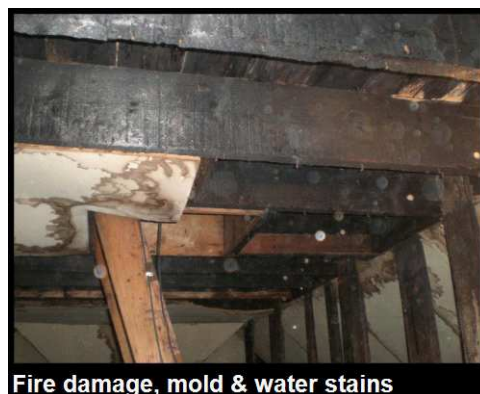
Fire damage, mold & water stains

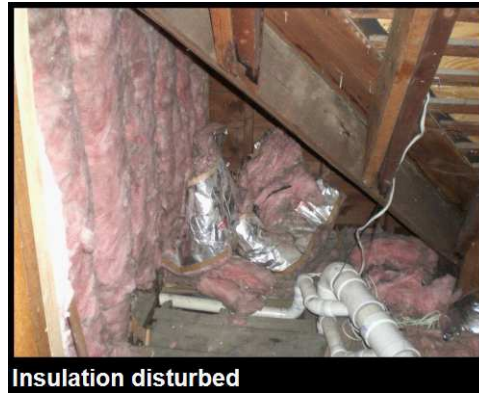
Fiberglass batts
insulation has been disturbed in some areas

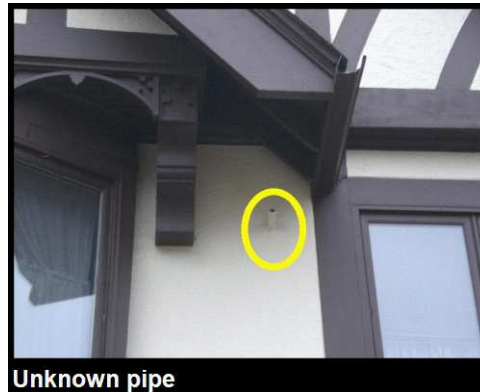
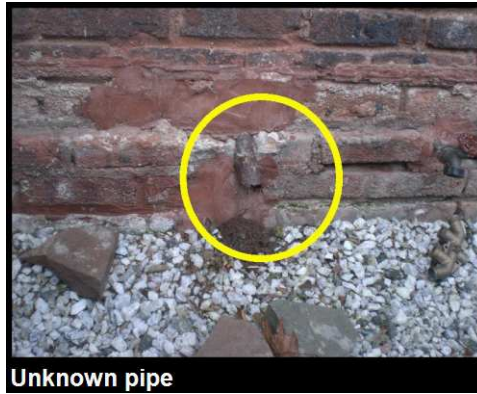
Appears serviceable, Minor corrosion is noted
Noted two pipes in the front of the home that we were not able to determine the need for. One pipe exits the front of the home next to the master bathroom window and one exits the front of the home near the ground level to the right side of the front stairs, further evaluation is recommended.

Unknown pipe

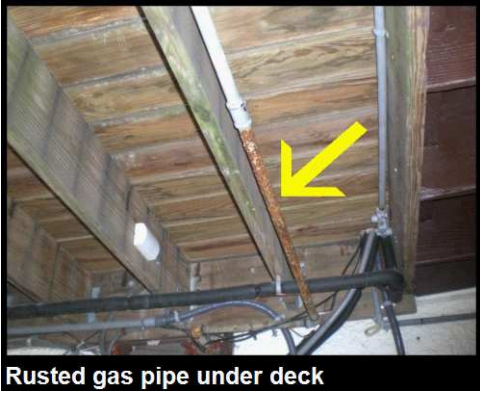
Rust and deterioration was noted on the gas pipe under the deck replacement is needed.

Rusted gas pipe under deck
